# **Longevity of Diamond-Ground Concrete Pavements**

Paper Prepared for Presentation at the 78th Annual Meeting of  
Transportation Research Board, January 10-14, 1999

### ABSTRACT

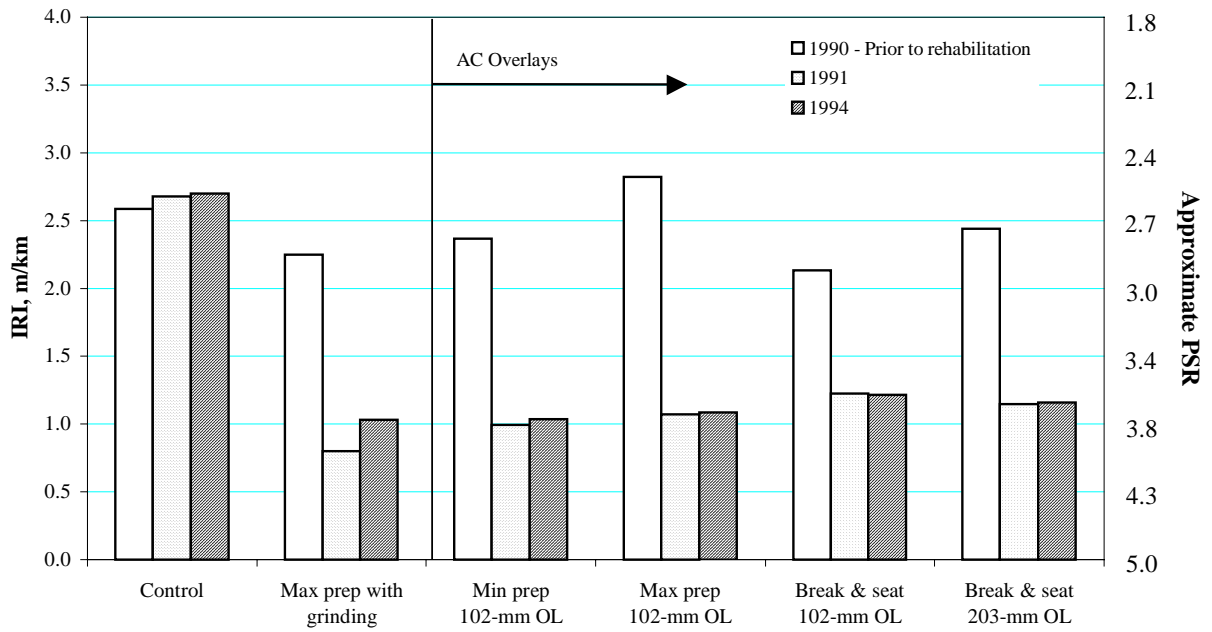
Figure 3. Roughness performance of diamond-ground and AC overlay sections at the Illinois SPS-6 site.

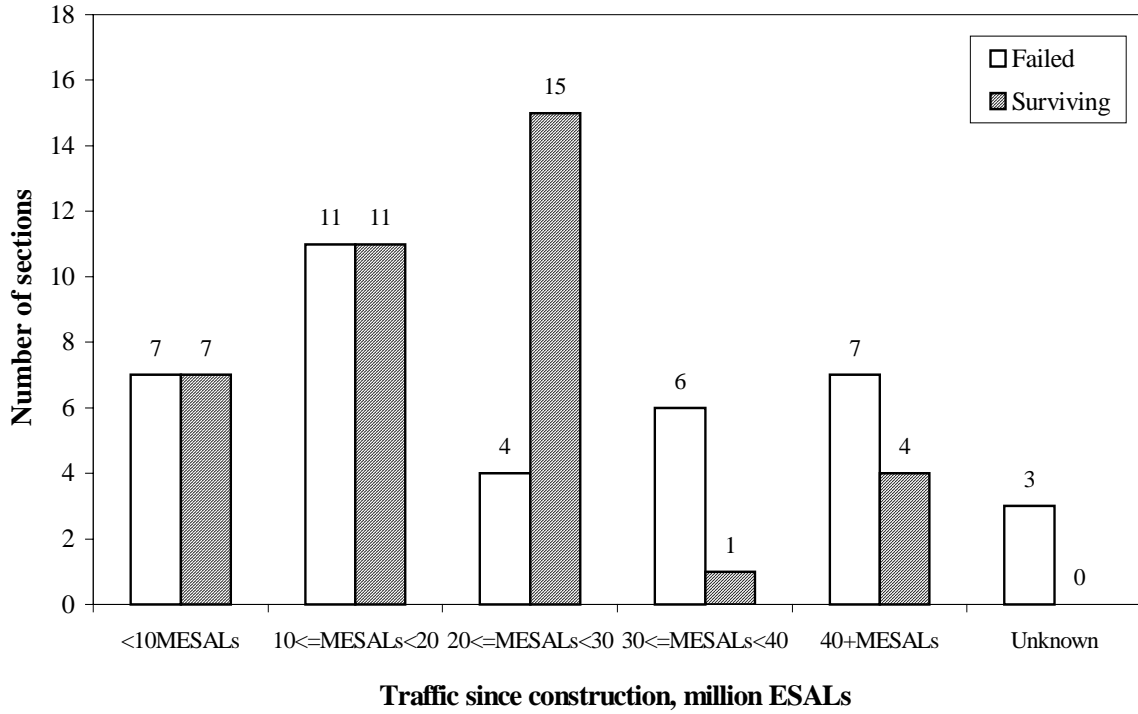
Figure 5. Distribution of traffic levels in the pavement sections for service life evaluation.

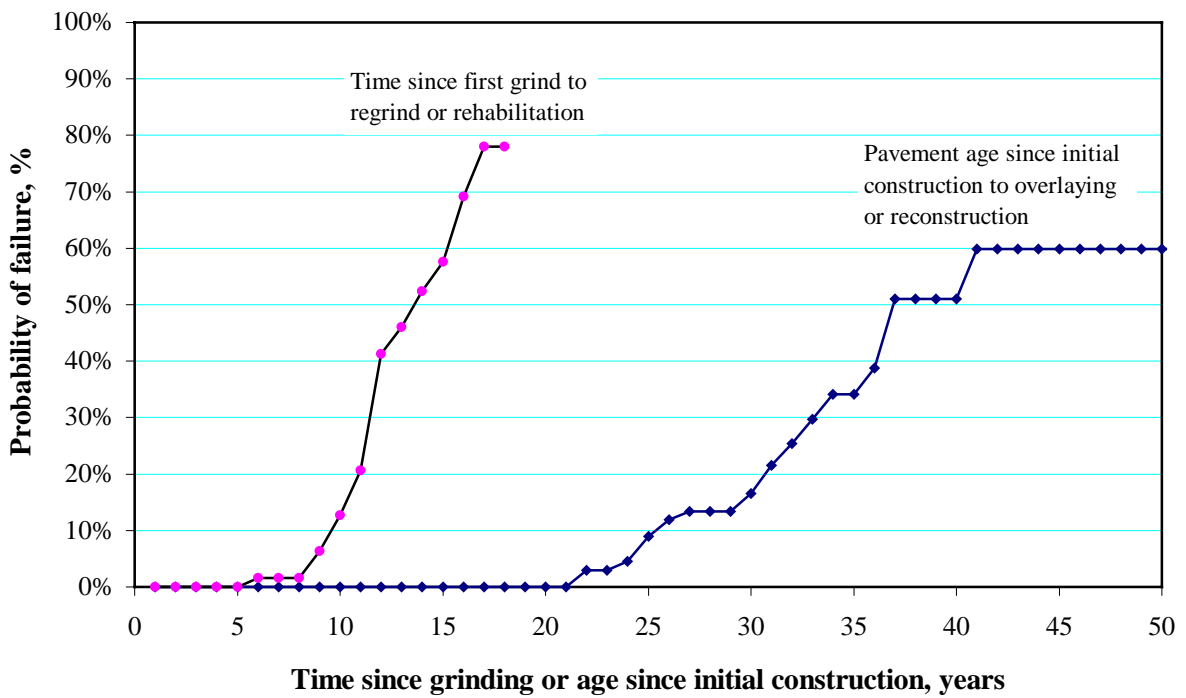
Figure 6. Survival curves for diamond-ground pavements.

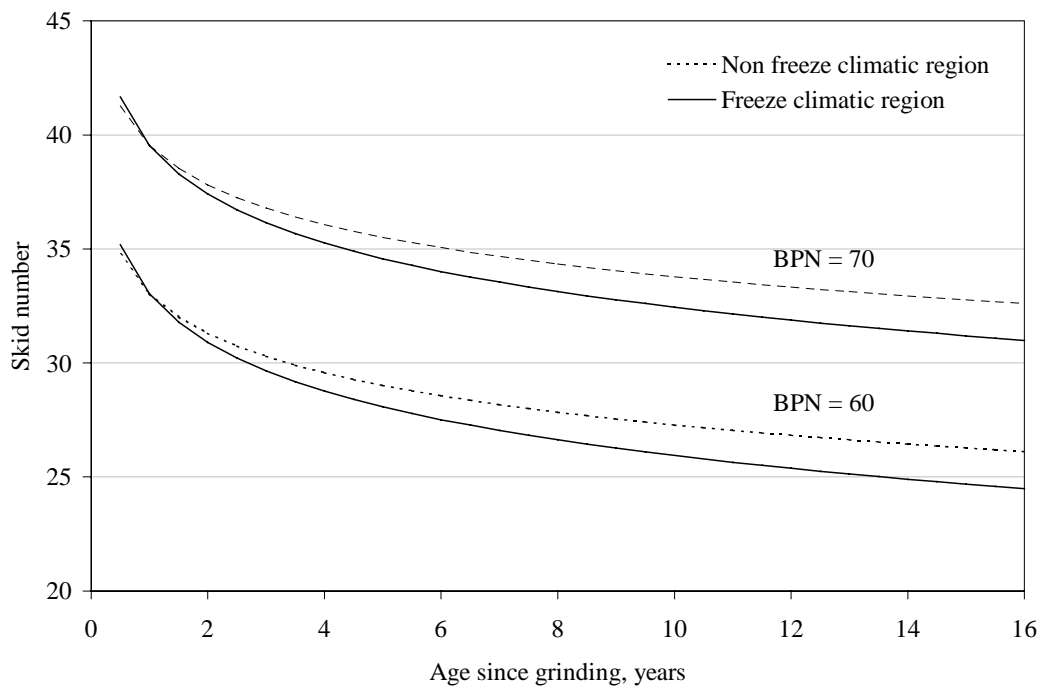
Figure 10. Predicted Structural Number (64 km/hr [40 mph]) after grinding for two values of British Pendulum Number, a measure of pavement microtexture.

Figure 9 is shown with a dashed reference line at 0.5 mm (0.02 in) to represent a nontextured concrete surface. The trend lines show that the reference level of texture is reached at age 8 years in the freeze region and at age 12 years in the nonfreeze region. Macrottexture depths can be correlated to skid number. The correlation results obtained using the model developed by Henry and Wambold (9) are shown in figure 10.

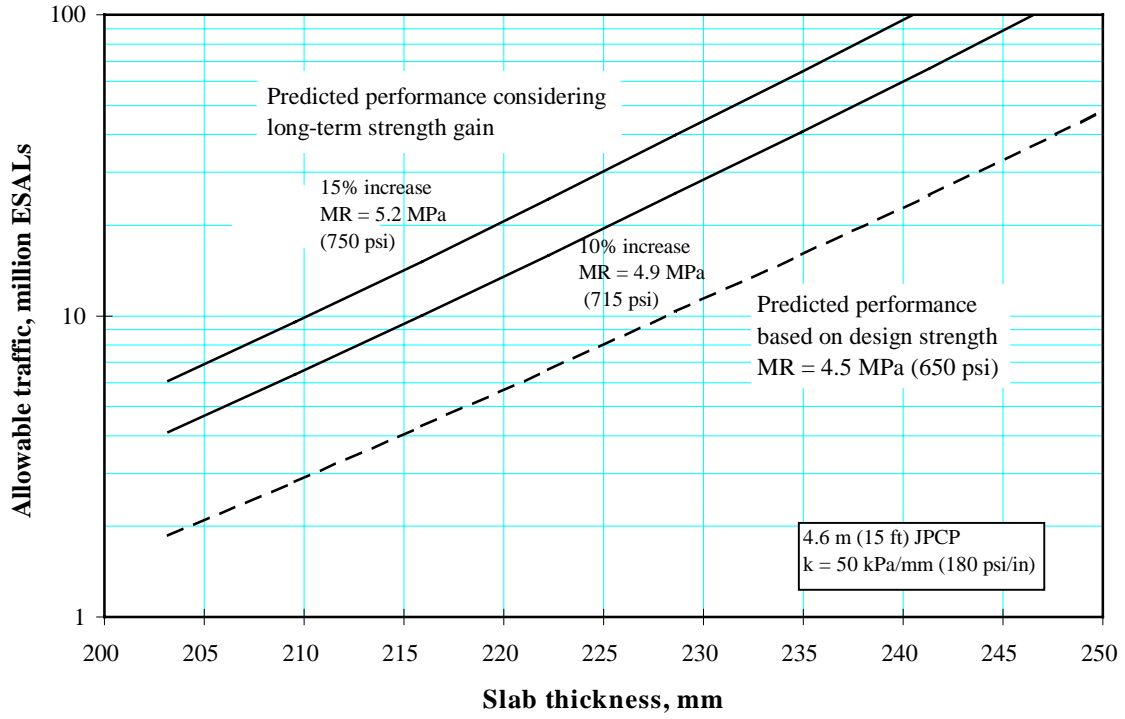
Figure 11. Effects of slab thickness and concrete strength on fatigue life of JPCP.

For the analytical evaluation, a fatigue analysis was conducted to examine the sensitivity of fatigue life to slab thickness and concrete strength. The results are shown in figure 11. The predicted fatigue life was determined using the jointed plain concrete pavement (JPCP) cracking model developed by Yu et al. (10). Fatigue life of a pavement slab is extremely sensitive to slab thickness. A 5-mm reduction in slab thickness results in about 30 percent reduction in fatigue life, if the concrete strength remains constant. However, long-term strength of concrete is significantly higher than the design strength, which is typically the 28-day strength. The strength of conventional concrete (non-fast-track) after 1 year can be up to 20 percent higher than the 28-day strength (11). If the increase in

Figure 11 shows that with 10 percent increase in concrete strength, up to 13 mm (0.5 in) of thickness can be removed and still achieve the design life predicted based on design strength. If the long-term strength is 15 percent higher than the design strength, up to 18 mm (0.7 in) may be removed without compromising the projected performance. These results suggest that a typical concrete pavement may be ground up to three times without compromising its fatigue life. The fact that several concrete pavements have been ground 3 times and are still performing well supports this result.

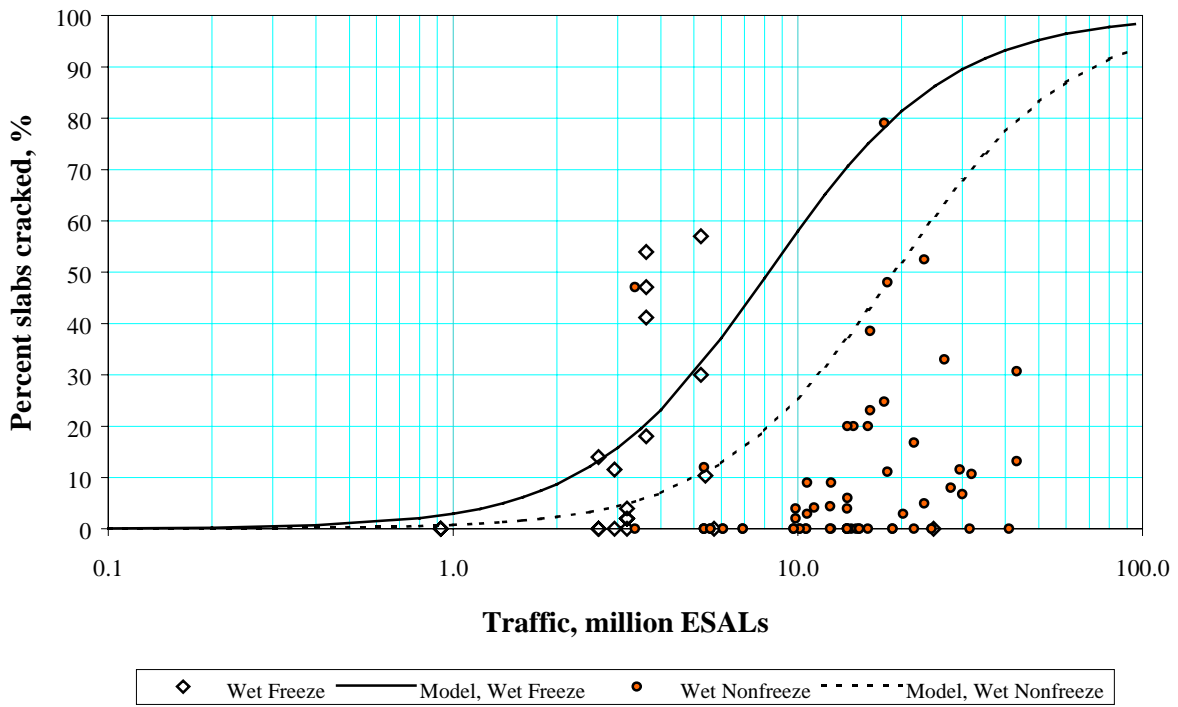
Figure 12. Comparison of predicted and observed cracking for JPCP sections in wet freeze and wet nonfreeze climatic regions.

The analytical results are consistent with the field observations. None of the pavement sections evaluated exhibited unusual levels of cracking. Figure 12 show the cracking data for the sections in wet freeze and wet nonfreeze climatic regions, along with the predicted performance for typical sections in each climatic region. This figure exhibits significant scatter because the plot includes pavement sections with significantly different design features. For the wet freeze region, the model predictions represent the average case, which means the unusually high levels of cracking are not observed in the field data. For the wet nonfreeze region, the predicted performance represents the upper bound of the cracking data, meaning that actual performance was better than predicted.
